Patricia A. Warke

Recording Stone Decay

Staging System Approach to Condition Assessment of Stonework

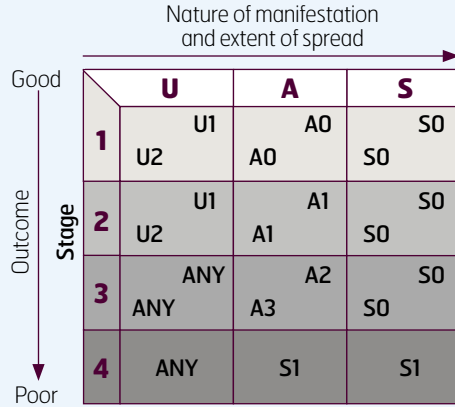
Figure 1
UAS Staging System grid showing the links between the extent and spread of stone deterioration and the condition stage which in turn gives an indication of the degree of intervention required and an assessment of potential outcome if no remedial treatment is undertaken. (Key to abbreviations in Table 1)

The Staging System comprises three categories that describe in general terms the extent of deterioration of stonework (Figure 1):

are combined they enable one of the four condition stages to be assigned to the building façade (Figure 1). The higher the numerical value of the stage identified, the worse the condition of the façade in question and the greater the extent of remedial

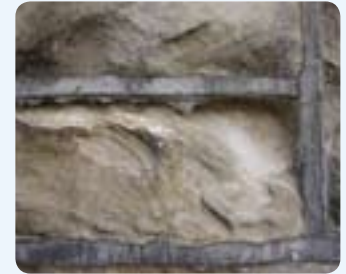
Figure 5

- Evidence of obvious surface stone decay through scaling, flaking and granular disintegration (ie; whether there is loose material on block surfaces that can be easily dislodged) (Figure 5);
- Presence and extent of

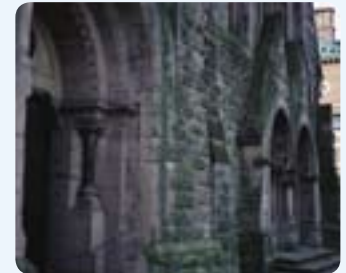
Figure 4

- Inappropriate pointing or mortar replacement with hard cement mortar can have a particularly widespread adverse impact on 'soft' stones such as sandstone as it prevents the natural expansion of stone associated with heating or wetting. This constraint typically

results in flaking and scaling around the edges of blocks (Figure 4). The presence of 'hard' mortar in association with deterioration of stone is a good indication that the mortar may need to be replaced. However, it is important to note that not all stone types are adversely affected by 'hard' mortars.

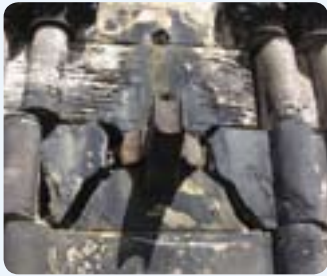
Figure 8

- Presence and extent of surface staining and/or soiling. Soiling may be widespread affecting most of the façade (Figure 7a) or may be related to some more localised factor where, for example, sections of the façade are sheltered from direct rainwash (Figure 7b);
- Presence of any other signs of stone alteration or deterioration such as fracture

development (Figure 8). Such features may be associated with failure of an individual stone block due to corrosion of metalwork or may indicate more serious structural problems.

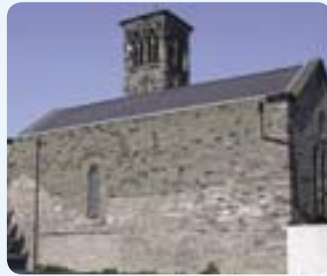
Figure 9

The above sequence should be repeated for each façade with the predominant stage value being used to represent the condition of the building as a whole (Table 4). In Table 4, if two façades had been classified as being Stage 3 and the other two as Stage 4 then an overall Stage 4 classification should be assigned to the building. It is unusual to encounter a building where there is a significant disparity between the condition of different façades but it can happen where, for example one façade has been protected from exposure to atmospheric pollution by the presence of

another building (**Figure 9**). If the sheltering building is subsequently demolished the newly exposed façade will present a very different appearance and condition to the rest of the structure. In such cases the predominant higher stage value should be recorded as being representative of the building as a whole. Some differences between the condition of separate facades is to be expected and may be related to aspect with the 'weather' side of the building often showing more evidence of deterioration.

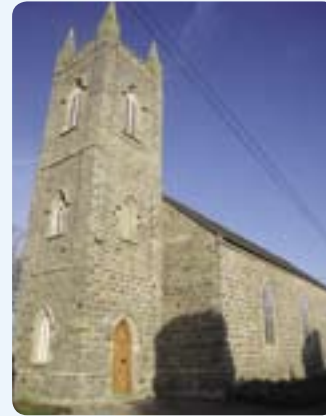
Billy Parish Church. A Gothic style chapel built in 1815.

Façade Condition Assessment Form											
		Pointing (L or C)* %	Mortar Repair %	Stone Replacement Type %	Clean/Treatment	Fracturing	Stone Decay	Soiling/Biological or Pollution	RW** Goods	Stage & UAS Scores	
Name of Building: Billy Parish Church											
Grid Reference: 2955829 438235											
FAÇADE DESCRIPTIONS	NORTH	Soiling: limited Decay: basalt in good order. Sandstone: courses eroded, weathering and flaking under window	100 L	0-2	0	yes	0	2-10	0-2	Good	1 U2 A0 S0
	EAST	Soiling: limited, mainly sandstone dressing- green patches of biological growth Decay: basalt in good order. Sandstone: surface granular disintegration under door archway. Heavy flaking under window arches, occasional flaking under courses	100 L	0-2	0	yes	0	2-10	2-10	Good	1 U2 A0 S0
	SOUTH	Soiling: limited, mainly chancel Sandstone and courses Decay: basalt in good order. Sandstone: surface granular disintegration on window. Replacement corner stone of lower course and door entrance	100 L	0-2	0-2	yes	0	2-10	2-10	Good	1 U2 A0 S0

WEST	Tower Soiling: clean, patches of bio on pinnacles Decay: basalt in good order. Sandstone: surface weathering and granular disintegration, older blocks weathered. Replacement blocks on courses & window	100 L	0-2	0-2	yes	0	0-2	0-2	Good	1 U2 A0 S0
RESULTS Certainty Factor: C2		100 L	0-2	0-2	yes	0	2-10	2-10	Good	STAGE 1

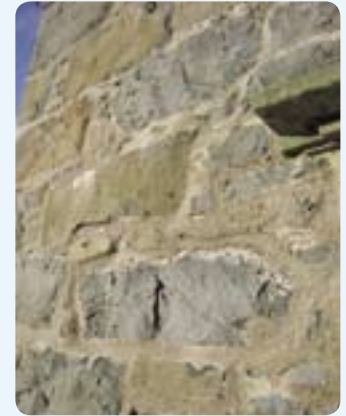
Basalt blocks, showing no evidence of deterioration.

A façade in this condition should require only localised remedial treatment concentrating on individual stone blocks. A staging classification of 1 may also indicate that no immediate intervention is required with only periodic reassessment of the façade being advised.

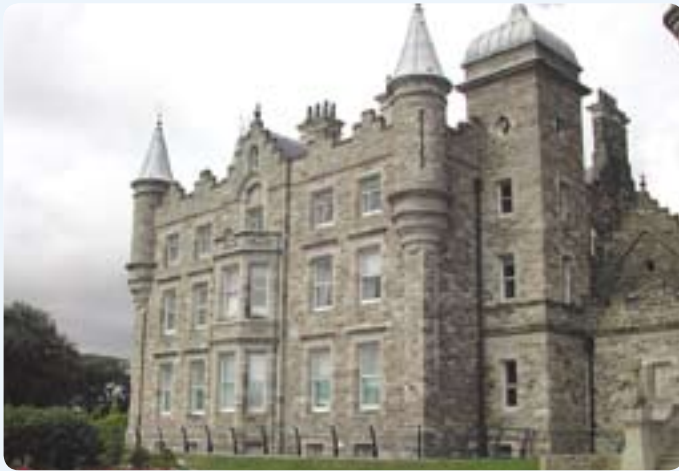
Stage 2 Classification

Stormont Castle, a Scottish Baronial style castle built in 1830.

Façade Condition Assessment Form										
Name of Building: Stormont Castle		Pointing (L or C) %	Mortar Repair %	Stone Replacement Type %	Clean/Treatment Fracturing	Stone Decay	Soiling Biological or Pollution	RW** Goods	Stage & UAS Scores	
NORTH	Modern Extension (not assessed)									
EAST	Soiling: mild black soiling across face, green biological growth in sheltered areas. Decay: mostly mortar damage, flaking and scaling around edges, some pitting, whole block faces.	100 C?	0-2	0-2	yes	0-2	30-50	>50	OK	2 U2 A1 S0
SOUTH	Soiling: mild black soiling across face, white and yellow lichen on lower string-course Decay: mortar damage causing flaking and scaling, whole block faces, occasional pitting and differential weathering	100 c?	0-2	0-2	yes	0-2	30-50	10-30	OK	2 U2 A1 S0
WEST	Soiling: mild black soiling across face, heavier and green biological growth on string-course and detail Sandstone??: same as above??	100 C?	0-2	0-2	yes	0-2	30-50	10-30	OK	2 U2 A1 S0

RESULTS Certainty Factor: C1		100 C?	0-2	0-2	yes	0-2	30-50	10-30	OK	STAGE 2

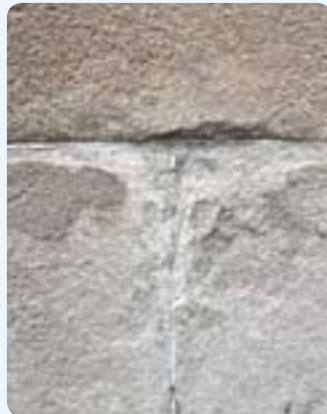
Deterioration of block corners.

Section specific remedial action would be required in this case but the extent of intervention should be relatively limited because of the lack of distant involvement within the façade boundaries.

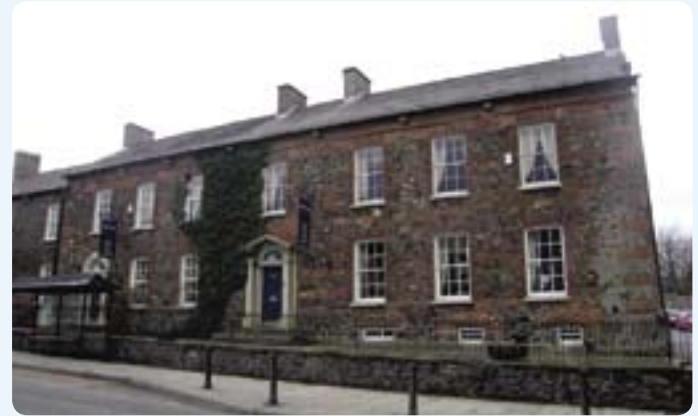
Stage 3 Classification Example: Moira, County Down

Late 18th Century, Georgian style house.

Significant intervention will be required on facades with this stage classification with up to 50% of the total façade surface showing evidence of significant deterioration. Although the extent of deterioration is severe, appropriate conservation treatment should prolong the life expectancy of the structure.

Façade Condition Assessment Form											
Name of Building: Main Street, Moira Grid Reference: 315143 360717		Pointing (L or C)* %	Mortar Repair %	Stone Replacement Type %	Clean/Treatment	Fracturing	Stone Decay	Soiling/Biological or Pollution	RW** Goods	Stage & UAS Scores	
FAÇADE DESCRIPTIONS	NORTH	Soiling: white lichen and green biological growth on plinth and some other blocks. Moss on plinth Decay: fewer sandstone blocks, mainly just quoins. Sandstone quoins: very bad, heavy scaling. Main stone fine, just fault-line fractures. Part rendered (40%) order. Sandstone: courses eroded, weathering and flaking under window.	100 c	0-2	0	No	0-2	0-2	2-10	OK	2 U2 A1 S0
	EAST	Rendered (not assessed)									
	SOUTH	Soiling: ivy in centre of façade, little or no biological growth Decay: Sandstone quoins and head stones over basement windows in very bad condition, severe scaling and major surface loss, mortar damage, 1 head badly fractured. Greywacke/basalt OK. Sandstone blocks in wall very bad, scaling and hollowed out in places. Some strap pointing at west end.	100 c	0-2	0	No	0-2	2-10	2-10	OK	3 U3 A2 S0

WEST	Rendered (not assessed)									
RESULTS Certainty Factor: C1		100 c	0-2	0	No	0-2	2-10	2-10	OK	STAGE 3

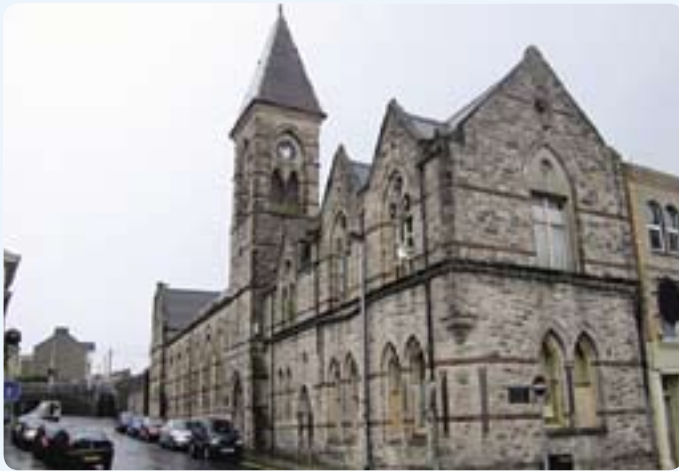
Stage 4 Classification

Larne Town Hall.

Serious deterioration affecting more than 50% of the total façade surface with stone decay detected on unconnected, distant portions of the façade. On a stage 4 category of façade, considerable intervention will be required to restore the stonework. If the structure is of limited historic and/or architectural merit then consideration may be given to the provision of supportive rather than restorative treatment.

Façade Condition Assessment Form											
Name of Building: Larne Town Hall		Pointing (L or C)* %	Mortar Repair %	Stone Replacement Type %	Clean/Treatment	Fracturing	Stone Decay	Soiling Biological or Pollution	RW** Goods	Stage & UAS Scores	
FAÇADE DESCRIPTIONS	NORTH	Soiling: Some vegetation at roof level, some biological growth Decay: Scaling and flaking across face. Loss of some faces of stone	100 C	0-2	0	No	0	>50	10-30	OK	4 U3 A2 S1
	EAST	Adjoining Building (not assessed)									
	SOUTH	Soiling: Heavy in corners, sills, and lower face Decay: Heavy scaling and flaking across face. Cracks in slate columns	100 C	0-2	0	No	0-2	>50	30-50	OK	4 U3 A2 S1
	WEST	Soiling: Biological growth on sills, courses, and tower, gables heavy. Some vegetation growth on gables and corner, slates clean. Decay: Heavy scaling, flaking of majority of exposed stone faces. Heavy loss of detail on door carving. Scaling on string courses. Loss of face occasionally Open joints. Broken slate columns in door	100 C	0-2	0	No	0-2	>50	30-50	OK	4 U3 A2 S1

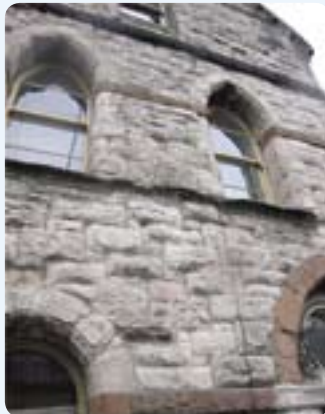
Widespread surface deterioration of stonework with loss of architectural detail.
